PUBLIC UTILITIES COMMISSION

GA2014-34

Subject: General Order (GO) 112-E Gas Inspection of San Diego Gas & Electric Company's, Miramar District, Transmission and Distribution facilities

Summary of Inspection Findings

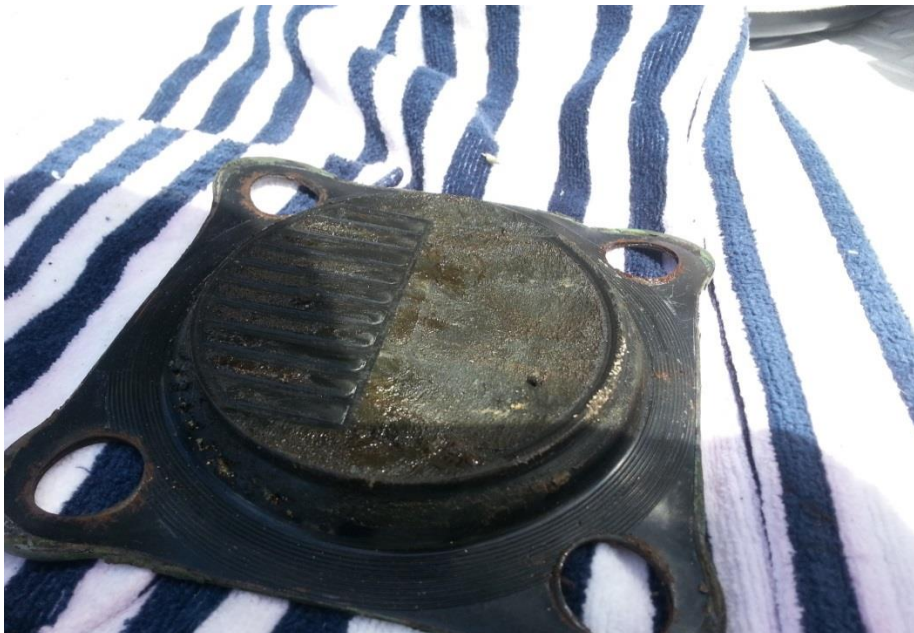
SED noted that since the downstream MAOP is 60 psig, the as-found pressure downstream of R1212 of 80-82 psig exceeded the MAOP plus 10%; therefore, this was recorded as an overpressure event.

SED noted that since the regulator failed to lock up, SDG&E personnel decided to tear it down to find out the cause and discovered that the regulator diaphragm was not working properly, see Photo-1, failed diaphragm, and changed it with a brand new one. Consequently, SDG&E leak surveyed the affected segment and found a small fuzz leak at one of the two meter set assemblies (MSA) and repaired it prior to leaving the site and SDG&E put the regulator station back in service on the same day. On 3/19/2014, SDG&E performed a second leak survey of the affected facilities and did not find any other leaks.

Photo 1- Close up view of the failed diaphragm of the regulator R1212 at SDSU

Please inform SED of the P&M measures taken to prevent similar failures in the future.
